GO Number	S/A Number	Page 1 of	Total Pages	Rev. Ltr/Chg. No. See Summary of Chg.	Number
97055	31170	145	145	NEW	EID-06141
Program Title Closure of ETEC (R21-RF)					
Document Title Hot Laboratory Decontamination and Dismantlement Final Report					
Document Type Engineering Information Document			Related Documents		
Original Issue Date 11/13/01		Release Date RELEASE 11/27/01 TV		Approvals Date	
Prepared By/Date D. W. Kneff D. M. Trippeda		Dept. 117 117	Mail/Addr T038 T038	R. D. Meyer	
IR&D Program? Yes <input type="checkbox"/> No <input checked="" type="checkbox"/> If Yes, Enter Authorization No.					
Distribution			Abstract

*	Name	Mail Addr.		<p>The former Rockwell International Hot Laboratory, located at Boeing Canoga Park's Santa Susana Field Laboratory in Ventura County, California, operated under Department of Energy funding from 1959 until 1987. It was used originally for the disassembly and examination of irradiated nuclear reactor fuel assemblies and test specimens, and later for the decladding of irradiated plutonium-bearing fuels from off-site reactors. Decontamination and decommissioning (D&D) of the facility was initiated in 1987, and facility dismantlement was complete

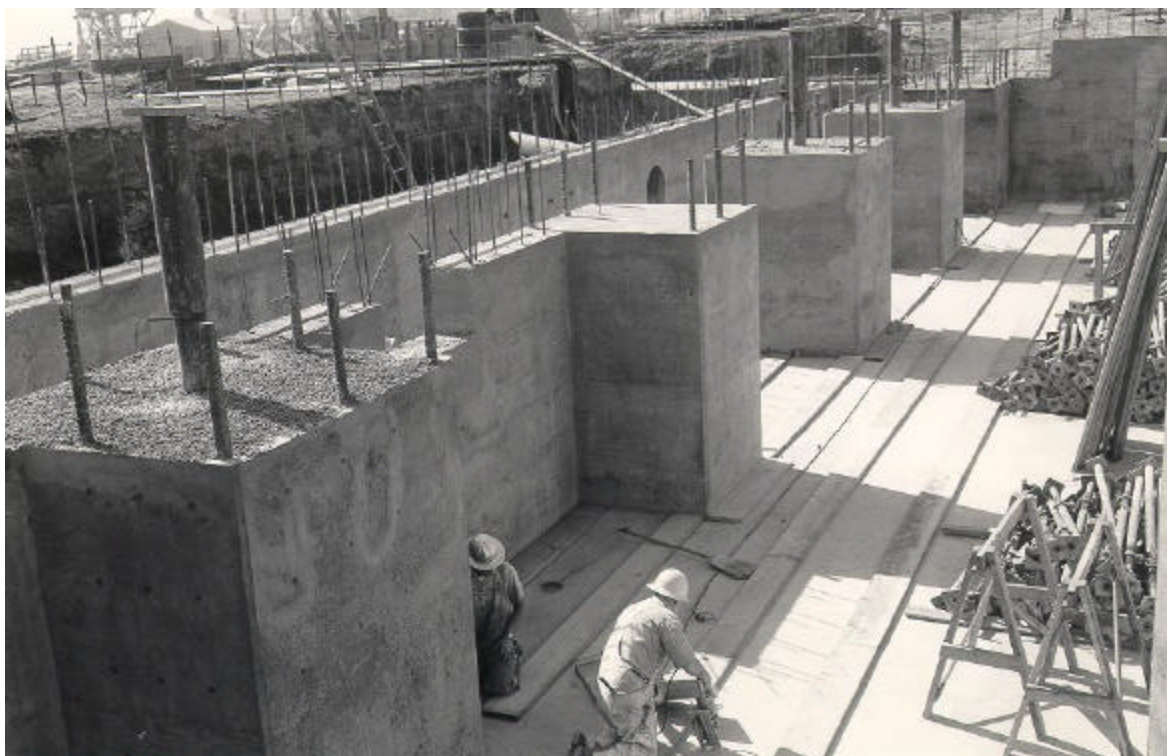
Figure 2-5. Building 4020 Basement During Construction. [00-5788B 8/22/58]

The concrete structure of the hot cells and decon rooms also included an underlying basement with 24-inch-thick concrete walls. The basement is shown schematically in elevation view in Figure 2-2, and in plan view in Figure 2-4. As indicated in Figure 2-4, the basement structure included five large concrete support columns which provide part of the structural support for the hot cells. Columns 1, 2, 3, and 5 (starting at the left in Figure 2-4) were constructed of steel-reinforced dense concrete and had 6½-foot-square cross sections. A carbon-steel pipe storage tube was embedded in the center of each of these columns, extending vertically downward from the hot cell floor a distance of about 12 feet. Column 4, also constructed of steel-reinforced dense concrete, had a 5-ft. 6-in. by 5-ft. 7½-in. cross section and formed part of an internal concrete wall. Figure 2-5 shows these basement columns during building construction.

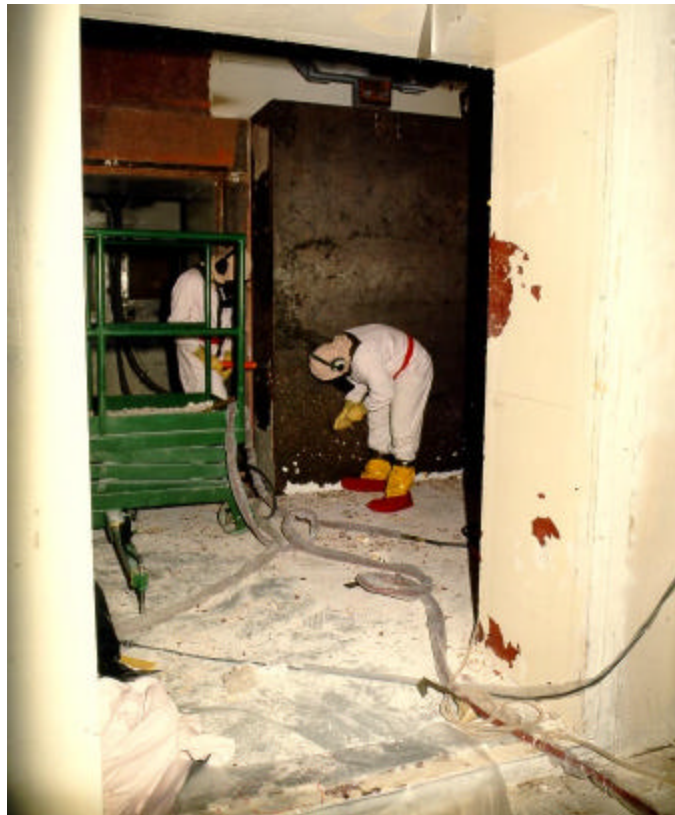
Figure 6-6. Surface Paint Removal in Cell 1. [6EH36-3/3/89-S1D]

The D&D plan for decontaminating the hot cells was based on the assumptions that the welded steel cell liners were intact and that radiological contamination was limited predominantly to the steel liner surfaces and the paint that coated them. Therefore, paint removal was initiated to remove this contamination after the cell walls and ceilings had been washed down. This was a multi-step process, first used in Cell 1 because that was the least contaminated of the four cells. The epoxy paint was removed first using needle guns, as shown in Figure 6-6. This was followed by additional scabbling and grit blasting to remove the primer and residual contaminated paint. The cell face and the slave ports were also grit blasted, with the cell face results shown in Figure 6-7. This operation resulted in the accumulation of paint chips and grit blast material in the cell. Those loose materials were vacuumed up and packaged for disposal as radioactive mixed waste, based on the lead content of the primer coat. The cell walls were then surveyed and any remaining contamination identified. Paint removal was also started on the one steel wall and three plaster walls of Decon Room 1. Figure 6-8 shows the walls of Decon Room 1 following paint removal.

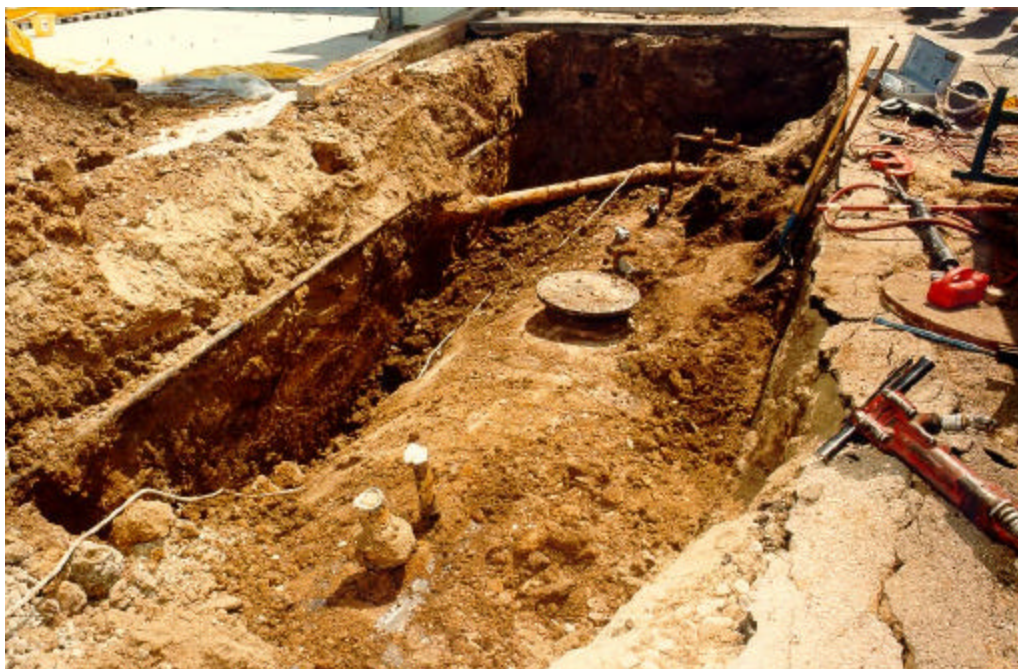
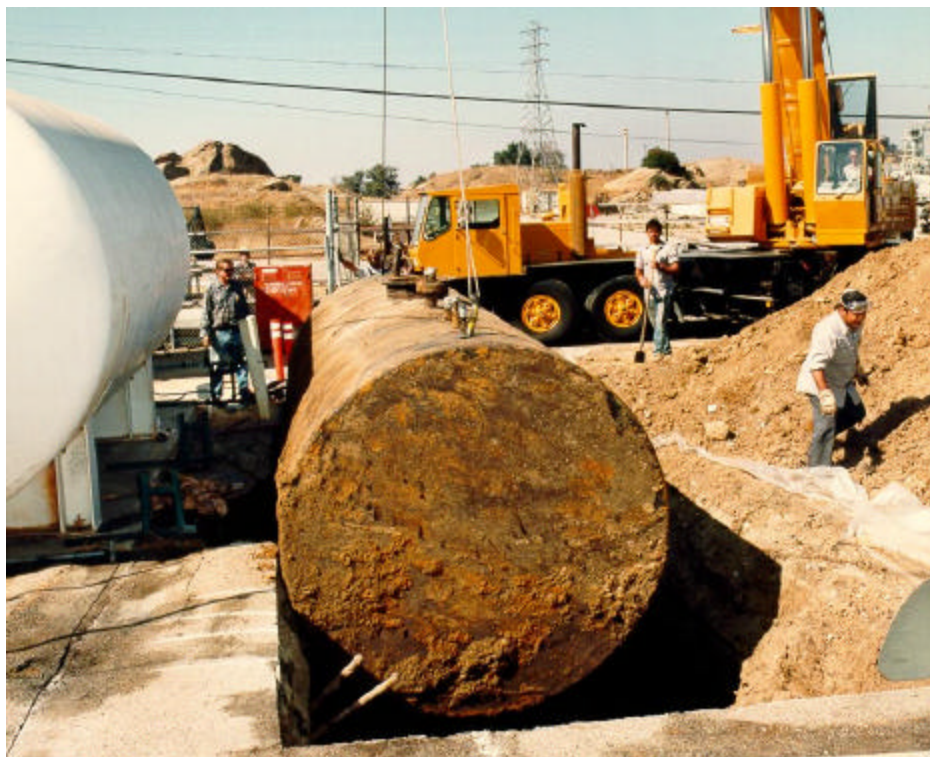
Figure 6-11. *Excavation of the Unused Underground Fission Gas Tanks.* [6DH21-8/30/89-S1C]

The three unused underground fission gas tanks located in the north yard were examined and found to be dry and radiologically clean. The tanks were excavated, as shown in Figures 6-11 and 6-12, surveyed clean, and disposed of as scrap metal. The excavated area was backfilled with clean soil, compacted, and repaved.

Figure 6-12. *Removal of the Underground Fission Gas Tanks.* [6DH21-8/30/89-S1B]

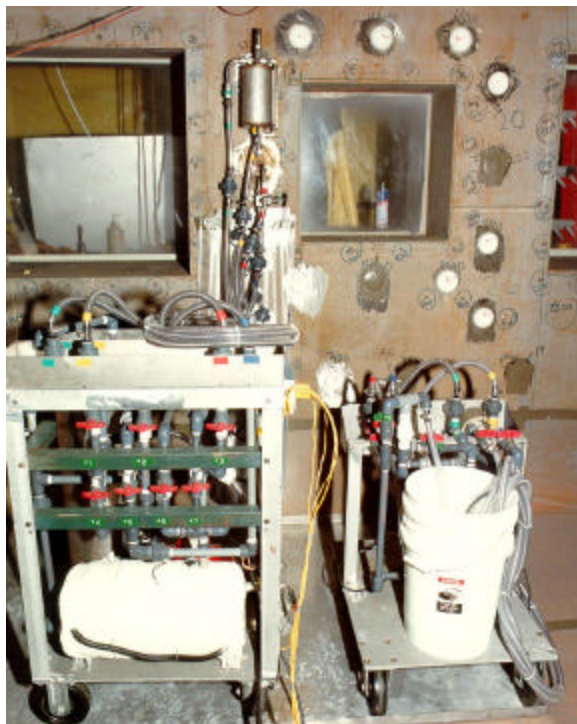
Figure 6-13. Electropolish Cleaning Equipment in Front of Cell 1. [6DH29-6/8/90-S1M]

The electropolish cleaning demonstration test on the Cell 1 operating gallery through-tubes was completed in FY 1990. Figure 6-13 shows the electropolish circulation equipment in place during work on the cell face. Paint removal was completed for the interiors of Cell 1 and Decon Room 1, and the surveying of the interior walls was substantially completed. Paint removal was initiated on the steel cell face of the operating gallery. This work was performed in a temporary HEPA-filtered negative air tent, as shown in Figure 6-14, to ensure contamination control and containment of all dust.

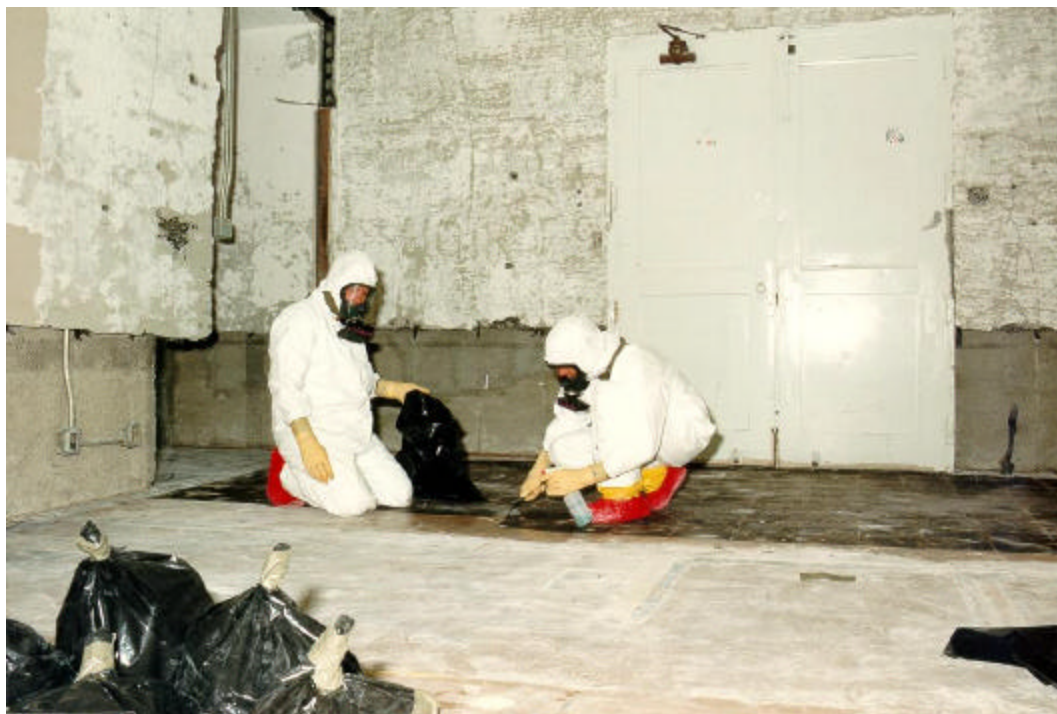
Figure 6-15. Floor Tile and Mastic Removal in the Manipulator Maintenance Room. [6DH66-7/5/90-S1D]

The floor tiles and underlying mastic were removed in the manipulator maintenance room (Room 128), as pictured in Figure 6-15. This photograph also shows the personnel protective clothing used for this type of activity. Radiological surveys identified contamination on the roof support beams in the air lock (Room 155) and the hot storage room (Room 153). The contamination was removed; in some areas the beams were jacked up to permit the removal of contaminated grout. All equipment was removed from the battery room (Room 137). Contamination in this room was found to be limited to the lower portion of the wall common to the hot metallurgy laboratory (Room 141). This entire wall was removed and disposed of as radioactive waste because of extensive contamination on the hot metallurgy lab side of the wall.

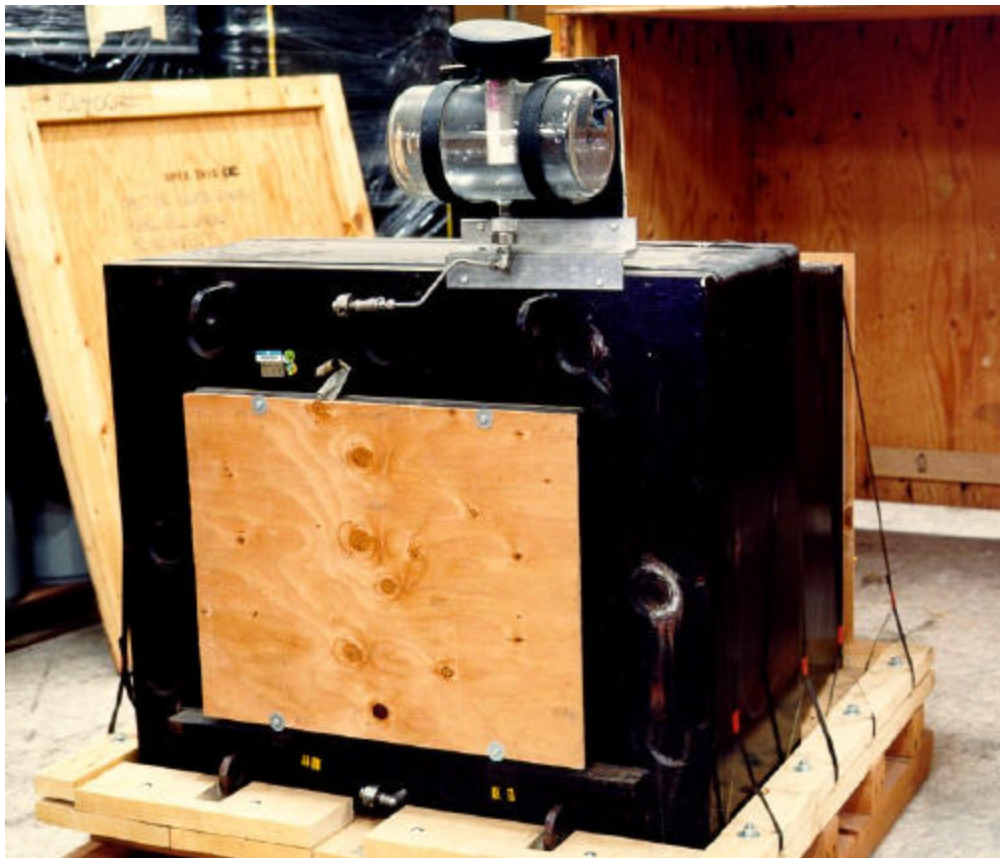
Figure 6-16. Hot Cell Window Palletized for Shipment to the University of Missouri for Reuse in Another DOE Program. [6DH91-11/8/90-SIH]

All remaining support equipment was removed from the hot cells and from Decon Room 3 and Room 4 during FY 1991. This included the in-cell cranes, electromechanical manipulators, manipulator rails, remote viewing periscopes, air ducting, nitrogen gas supply piping, storage well plugs, and filter racks. Equipment was transferred to other programs or applications where practical, and otherwise disposed of as clean or radioactive waste as appropriate. For example, manipulators, cell components, and other equipment that could be reused beneficially by the University of Missouri in a DOE-sponsored program were decontaminated to meet university requirements and shipped to the university. Figure 6-16 shows one of the oil-filled cell windows during packaging for shipment.

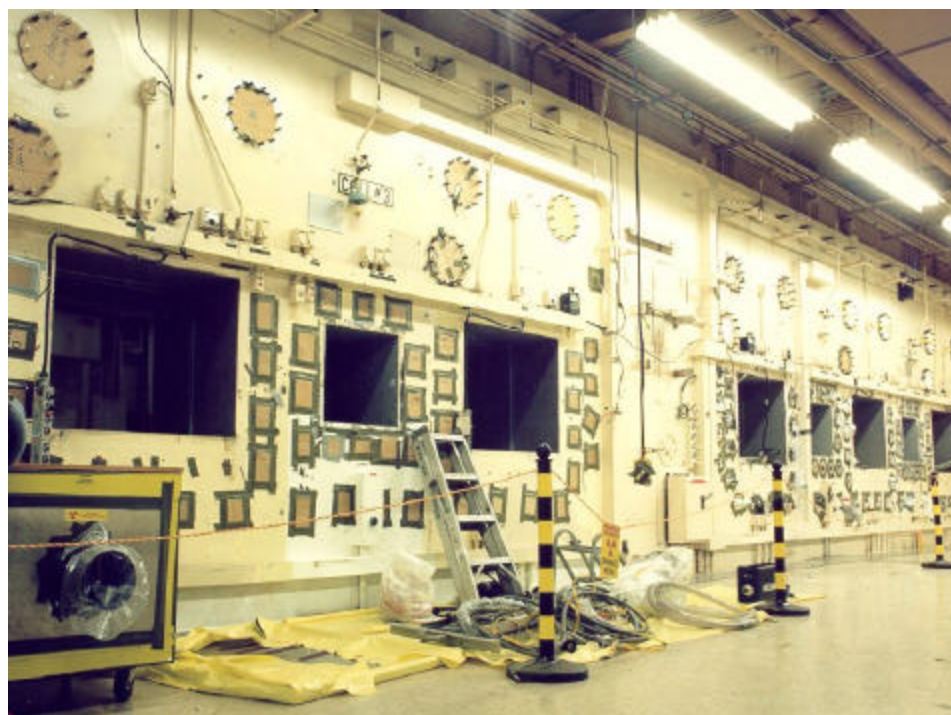
Figure 6-18. Status of Operating Gallery Faces of Hot Cells 3 and 4 in January 1991. [6HD29-1/24/91-S1B]

Paint removal was completed in Cell 2 and in Decon Room 2. By the end of FY 1991, Cells 1 and 2 and Decon Rooms 1 and 2 were surveyed and ready for the removal of localized areas of contamination. Cell through-tube decontamination work continued during the early part of FY 1991. For example, Figure 6-17 depicts through-tube honing operations on Cell 3 wall penetrations, from the operating gallery side. Figures 6-18 and 6-19 show the status of the operating gallery cell faces in January 1991.

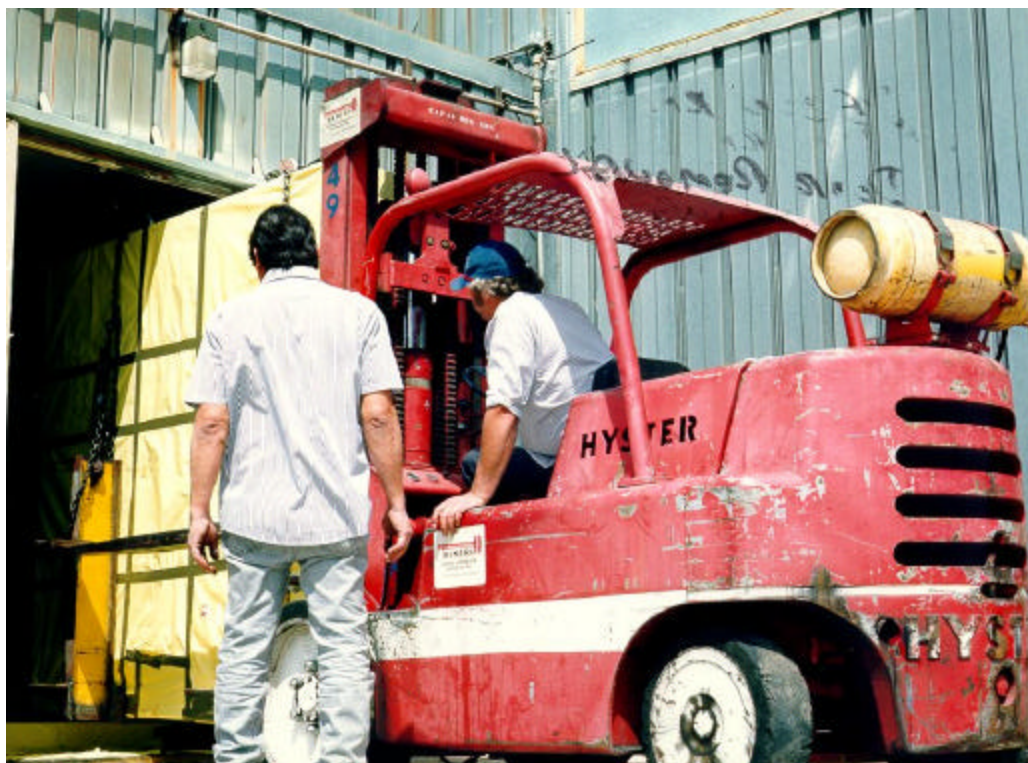
Figure 6-21. *Removal of the Decon Room 2 Shield Door from Building 4020.* [6DH29-4/17/91-S1H]

As a result, a specialty heavy-lift rigging contractor was hired to remove the shielding doors for subsequent decontamination at the RMHF. The four decon room doors were removed and transferred to the RMHF in FY 1991. Figure 6-21 shows the removal of the Decon Room 2 shield door, and Figure 6-22 documents the transport of two doors by flatbed truck. Temporary plywood covers with personnel doors were installed on the decon room door openings to maintain radiological containment and air flow in the cells and decon rooms. Hot Laboratory technicians removed and disposed of the door trolleys and support rails.

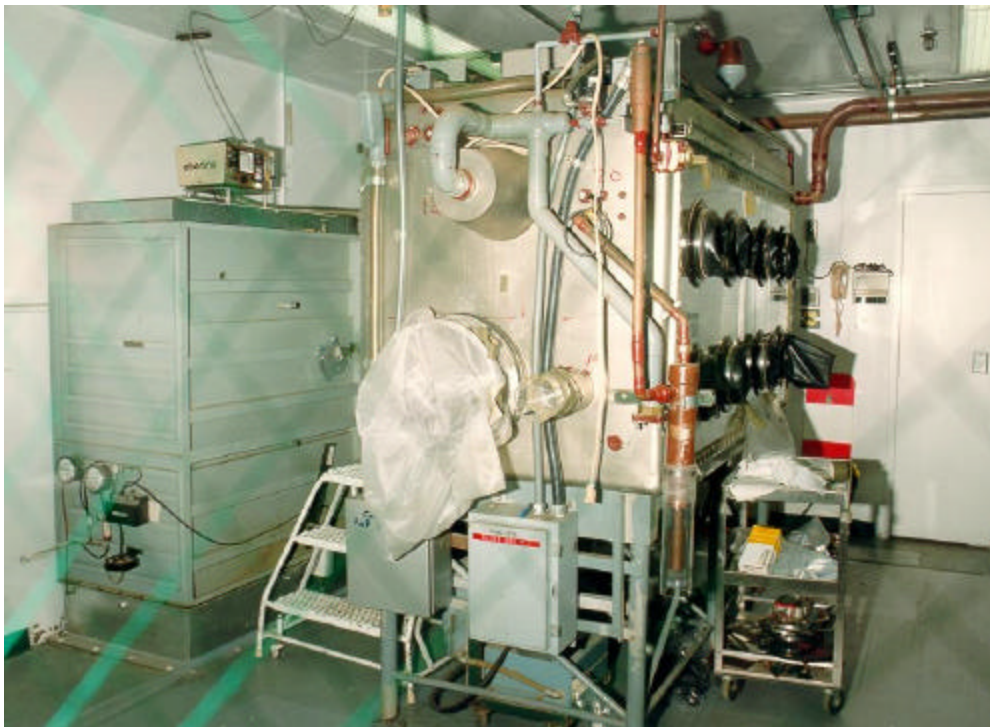
Figure 6-23. One of the Two Glove Boxes in Room 139 Prior to Removal. [6HD29-5/18/90-S1G-8]

Work resumed on equipment removal from, and decontamination of, the support areas that contained low levels of radioactivity. Those areas included the glove box laboratory (Room 139), the hot laboratory (Room 141), and the manipulator maintenance room (Room 128). Room 139 contained two glove boxes that had been installed for the handling of alpha-emitting materials, one of which is depicted in Figure 6-23. One of the two glove boxes had not been used and was removed for recycling after surveys confirmed that it was clean. The second glove box was contaminated, and underwent extensive decontamination to enable its packaging and disposal as low level radioactive waste.

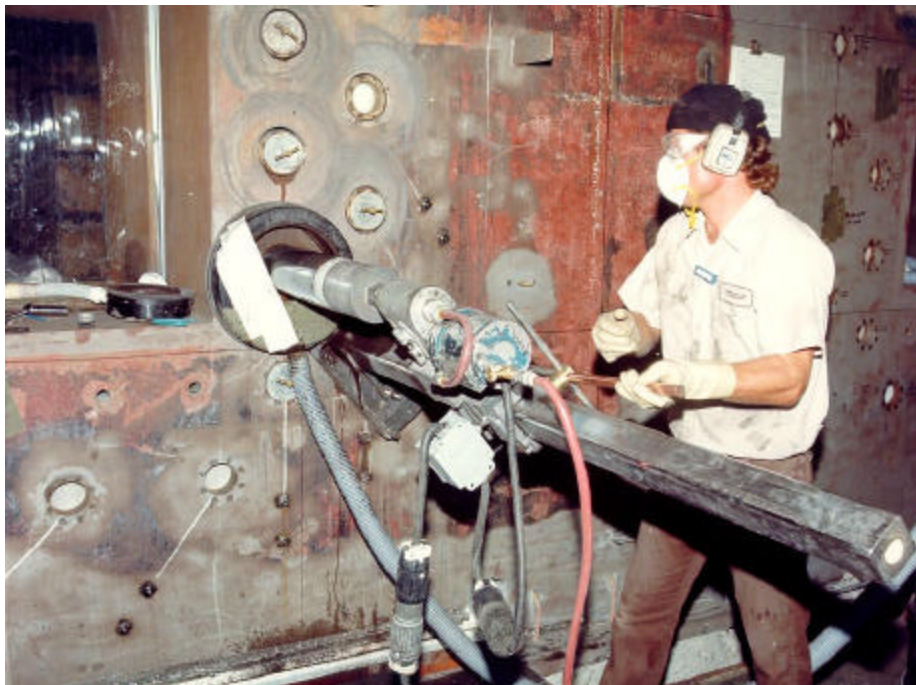
Figure 6-24. Core Drilling Operations to Remove the Hot Cell Penetration Through-Tubes. [ETEC-6/8/92-393174]

The core drilling operations were performed by an outside specialty contractor, who drilled from the operating gallery side, with its radiologically clean cell face, toward the contaminated interior cell face. This operation is pictured in Figure 6-24. The coring operation was stopped about 1 inch short of penetrating into the cell, leaving an intact barrier. This enabled the contractor operations to be conducted in a clean, non-radioactive environment. The cores were then broken loose and removed from inside the cells by Rocketdyne radiation workers, as depicted in Figure 6-25. The excess clean concrete was broken off from the core surfaces and the remaining cores, containing the steel tubes, were packaged and disposed of as radioactive waste. The cooling/lubricating water from the drilling process was collected, verified to be radiologically clean, and disposed of as clean waste. This collection method prevented the flow of cooling water into the contaminated cells, which could spread contamination and generate additional radioactive waste. During the period June to August 1992, a total of 466 cores were drilled with diameters ranging from 5 to 9 inches.

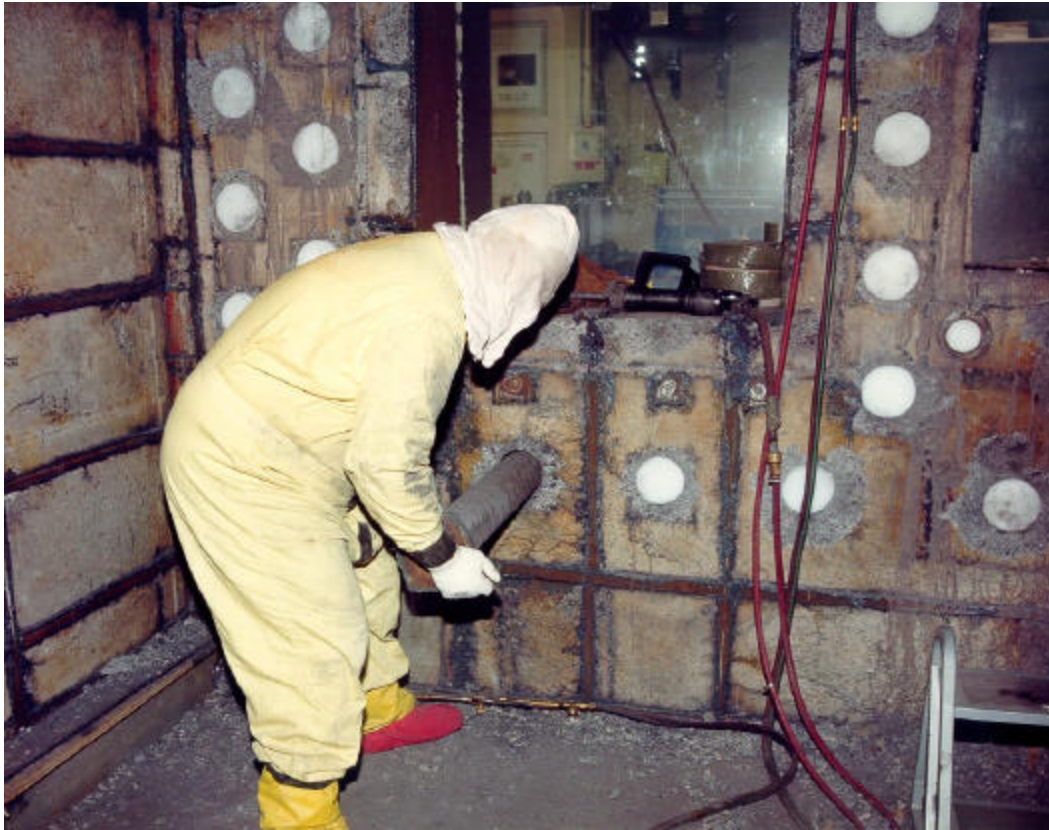
Figure 6-25. Removal of Concrete-Encased Through-Tube Cores by Rocketdyne Radiation Workers. [ETEC-6/8/92-393168]

Based on the success and efficiency of the through-tube removal by core drilling, a similar procedure was used to remove the cell window frames and the large-diameter master/slave manipulator through-tubes. Here the core drilling technique was used to drill a series of holes around the perimeter of each of the windows and manipulator ports. These ports were then broken free, size-reduced, and packaged for disposal. This procedure was found to be far more cost-effective than cutting out the frames and manipulator tubes and then jack hammering out the surrounding contaminated concrete. When the cores were removed, the holes were re-plugged with Styrofoam seals to control building ventilation and maintain a negative, HEPA-filtered air flow in the cells and decon rooms.

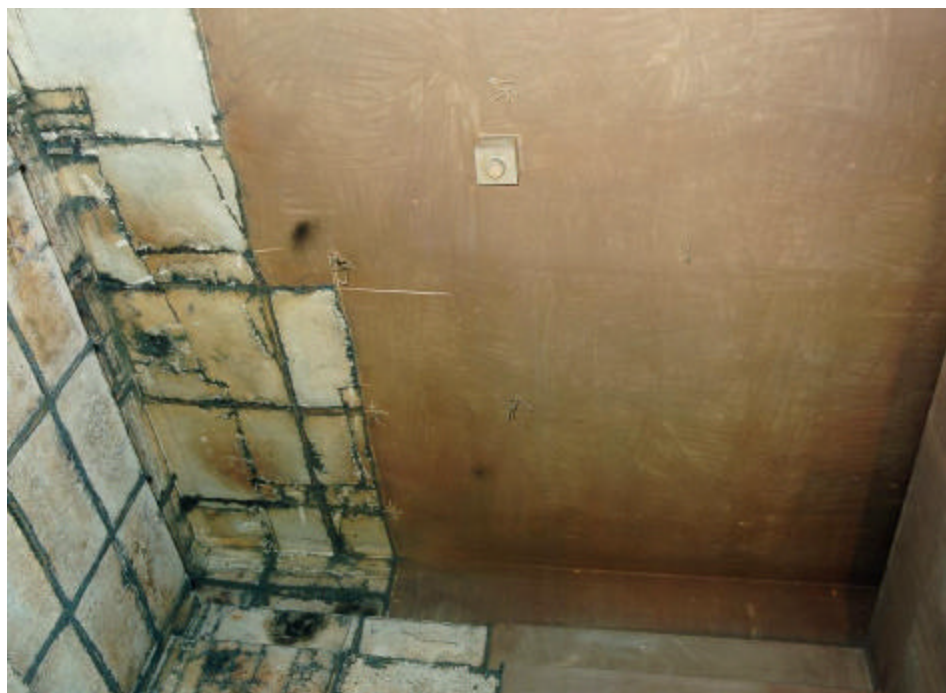
Figure 6-27. View of the Ceiling and Upper Walls of One of the Cells During Liner Removal Operations. [ETEC-03/16/92-P393063]

Removal of the Cell 1 wall liner was initiated using oxygen/acetylene torches by Rocketdyne technicians. This was a tedious procedure, as removal required cutting individual pieces within the steel strut support grid. By the end of FY 1992, all of the wall and ceiling liner plate had been removed from Cells 1, 2 and 3, and approximately 90 percent of the liner in Cell 4 was removed. Figure 6-27 is a photograph of the ceiling and upper walls of one of the cells during removal operations, showing the liner and the steel support grid in areas where the liner had been removed. Figure 6-28 is a view of a cell interior wall with the liner removed, again showing the steel support structure. The concrete walls were surveyed following liner removal, and areas of contamination were marked and removed by scabbling. The decontamination of cracks in the concrete and contaminant pathways along the steel struts in the concrete required significant effort. Gamma radiation levels of up to 2 R/h were found along the steel struts near cell crane rails at concrete depths of 2 to 3 feet. They were the result of cell wash-down water carrying contamination into the cracks during facility operations.

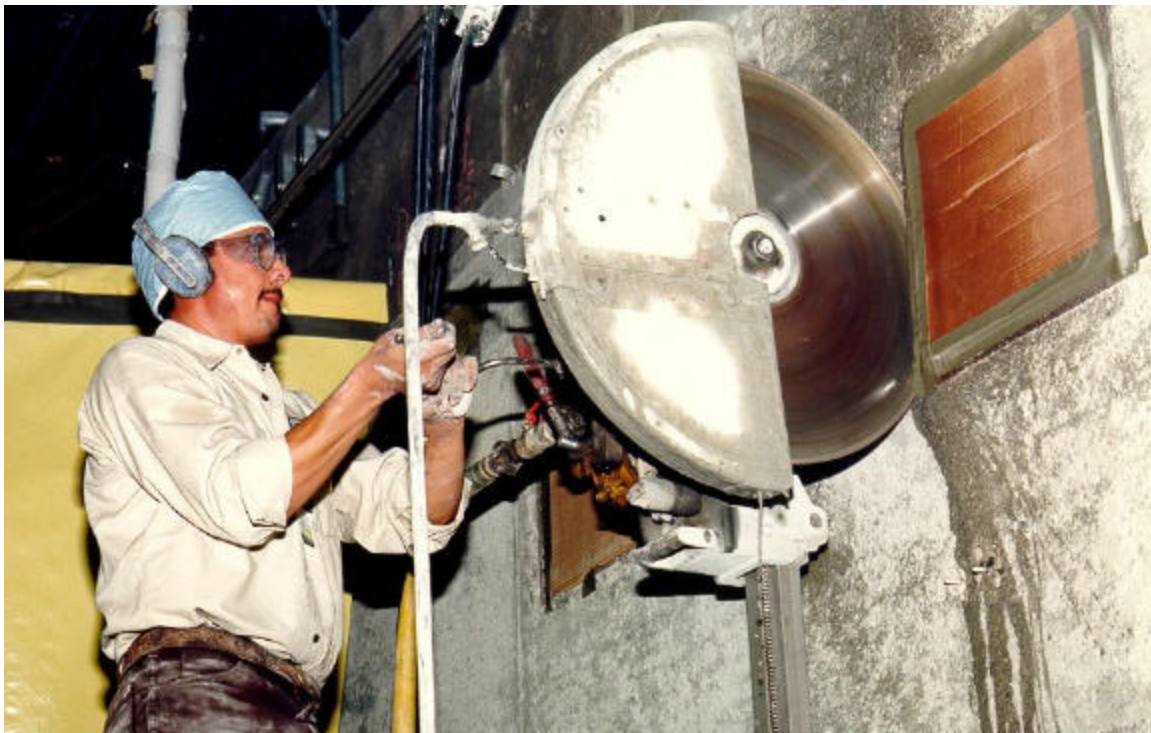
***Figure 6-29. Diamond-Blade Sawing of the Decon Room Door
Notches for Removal of the Cell Doors. [ETEC-8/4/92-P393286]***

The removal of the decon room concrete doors took place in FY 1991, as described in Section 6.5. In FY 1992, work was initiated to remove the larger steel hot cell doors. The four cell shield doors that separated the hot cells from the decon rooms were too tall to pass through the existing decon room door openings. A specialty concrete sawing contractor was hired to cut notches above the decon room door openings for clearance to remove the cell doors. This involved the use of diamond-blade sawing, as shown in Figure 6-29. In addition, the west wall of the service gallery was opened up to allow door removal from the building, and the north doorway of the mockup area was enlarged to provide clearance for the cell door located on the north wall of Cell 4. Figure 6-30 is a view through the service gallery door to the Decon Room 1 opening, showing the notches cut in both doors.

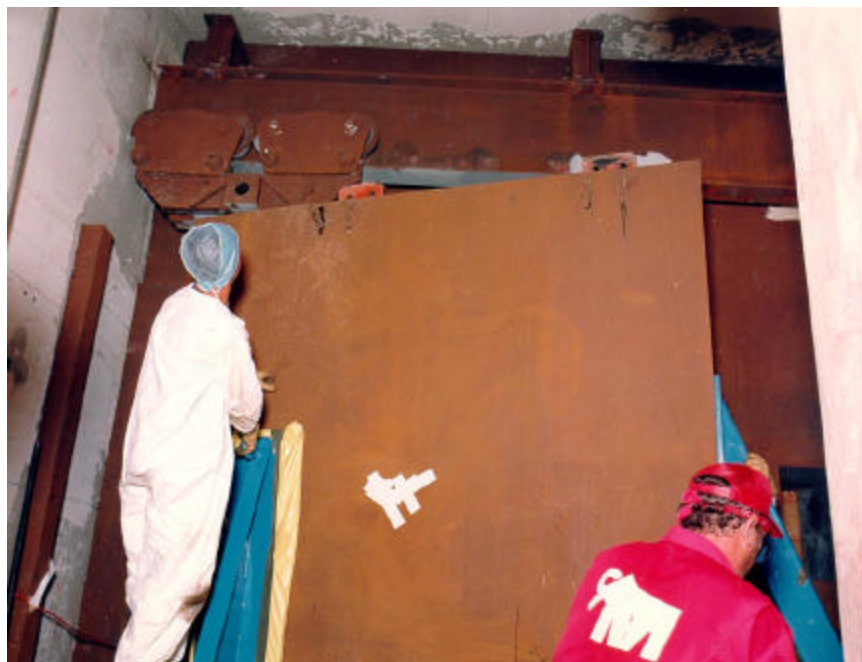
Figure 6-31. Removal of the Cell 1 Shield Door from Its Support Beam. [SF31-8/11/92-S1007]

The cell doors from Cells 1, 2, and 3 were removed by the specialty rigging contractor who had removed the decon room doors in FY 1991. This process is depicted in Figures 6-31, 6-32, and 6-33. Figure 6-31 shows the removal of the Cell 1 door from its support beam, Figure 6-32 shows the rigging used for its movement out of the building, and Figure 6-33 is a view of the lifting operation for loading the door onto a flatbed transport trailer. The doors were transported to the RMHF for decontamination.

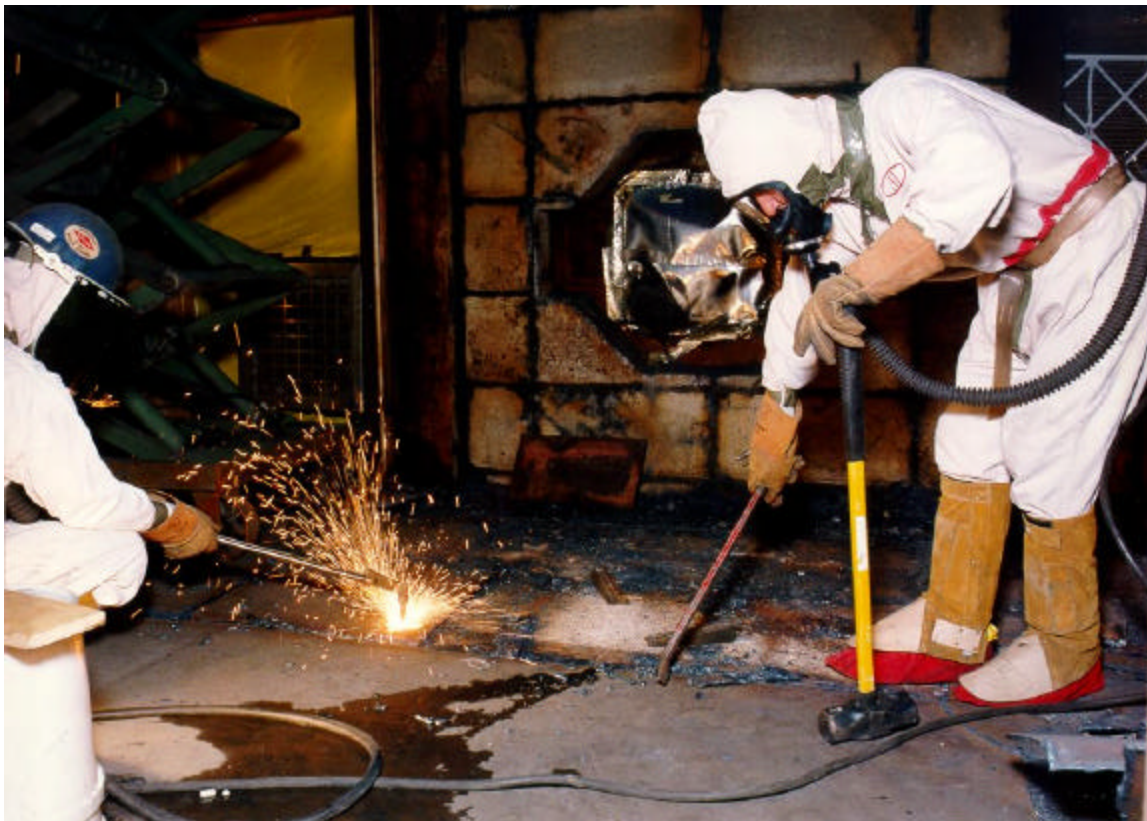
Figure 6-34. Oxygen/Propane Cutting of the Decon Room 3 Floor Liner for Removal. [AA33-1/26/93-S1002]

The concrete under the floor liners in the cells and decon rooms was found to have widespread contamination, as was previously observed for the walls. Concrete was removed from the floors in all of the cells and decon rooms to depths up to 6 inches using scabblers and jackhammers,

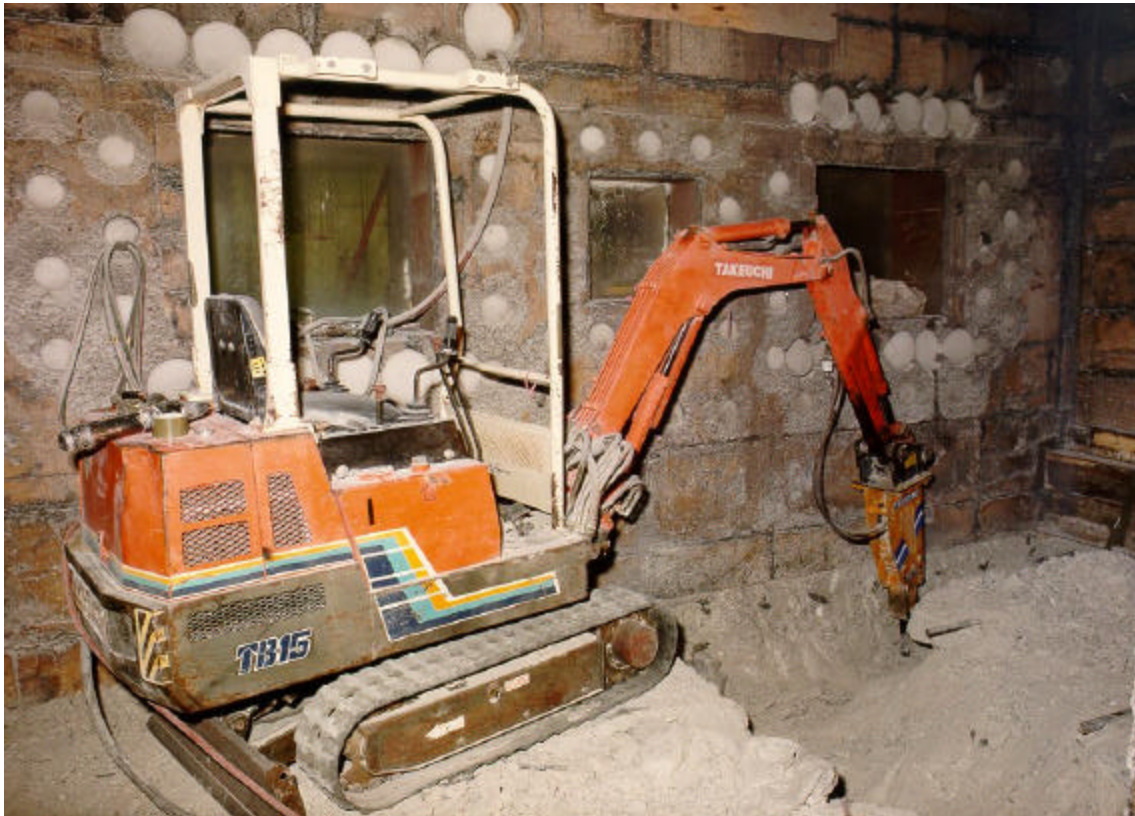
Figure 6-35. Track-Mounted Backhoe Used for Floor Concrete Removal Inside the Hot Cells and Decon Rooms, Shown with the Hydraulic Hammer Attached. [AA31-07/14/93-S1002]

and was packaged as radioactive waste. Contamination was also found in the expansion joint between the Cell 4 north wall and the mockup area concrete floor around the north shield doorway, and was removed. Concrete removal equipment included small scabblers, 90-lb. jack hammers, and two specialty vehicles that were capable of working inside the cells and were employed to expedite concrete removal and reduce personnel fatigue. One of those vehicles was a small track-mounted backhoe, pictured in Figure 6-35, which was equipped with two interchangeable end effectors: a 200-lb. pneumatic hammer and a small bucket. The second vehicle, shown in Figure 6-36, was a wheel-mounted skip loader that operated a similar hydraulic ram and a larger bucket. Hydraulic fluids were replaced with nonhazardous fluids, similar to those used in vegetable processing plants, in order to avoid the potential generation of mixed wastes in the event of a fluid leak. Extensive monitoring was performed to determine whether exhaust fumes from the diesel motors posed a personnel hazard in the confined work spaces. This was found to be a non-issue because of the rapid air turnover by the facility ventilation system. Both specialty vehicles proved to be efficient and cost-effective.

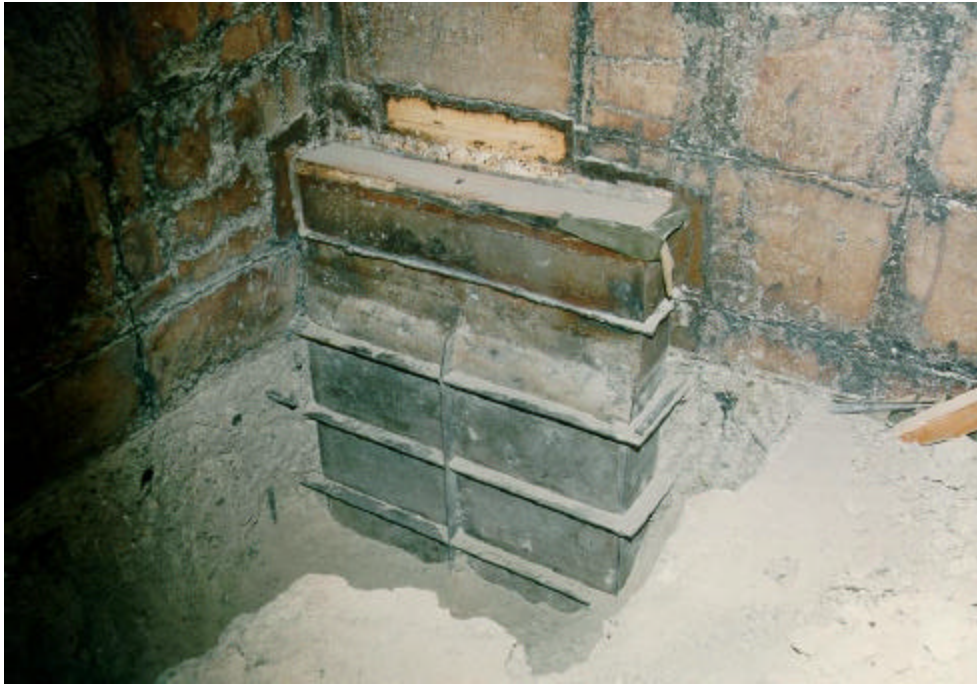
Figure 6-37. Cell 3 Exhaust Duct During Removal. [ETEC-07/28/93-393883]

The cell radioactive exhaust ducts that serviced the hot cells were located in the cell floors and ran to plenums and the central HEPA filter/blower system in the basement. The Cell 3 exhaust duct, for example, is pictured in Figure 6-37 (during removal). The hot cell and decon room drain lines (Figure 2-6) were encased in the cell floor concrete and ran to headers and then to a central line that led to the radioactive holdup tank in Building 4468. In many locations, the drain lines and the HEPA duct system intersected or were oriented in a manner that caused access interference. The HEPA ducts were removed first in order to provide access to the radioactive drain lines embedded below them. This included the back-to-back inlet ducts in Cell 1 (north side) and Cell 2 (south side), plus the encasing concrete, and the exhaust duct elbows (Figure 6-38) from all four cells. In many cases, duct removal from the 4-foot-thick cell floor slab required concrete removal from the top (cell floor) and the bottom (basement ceiling), with the latter requiring overhead work. Exhaust duct size-reduction and packaging were performed in an isolated section of the basement. Gasketed joints between duct sections contained asbestos and were segregated for separate packaging and disposal. The exhaust duct valves and ducting in the basement below all four cells were then removed, size reduced, packaged, and transferred out of the basement. The exhaust system for the decon rooms was maintained in service to ensure proper ventilation during final stages of cell decontamination.

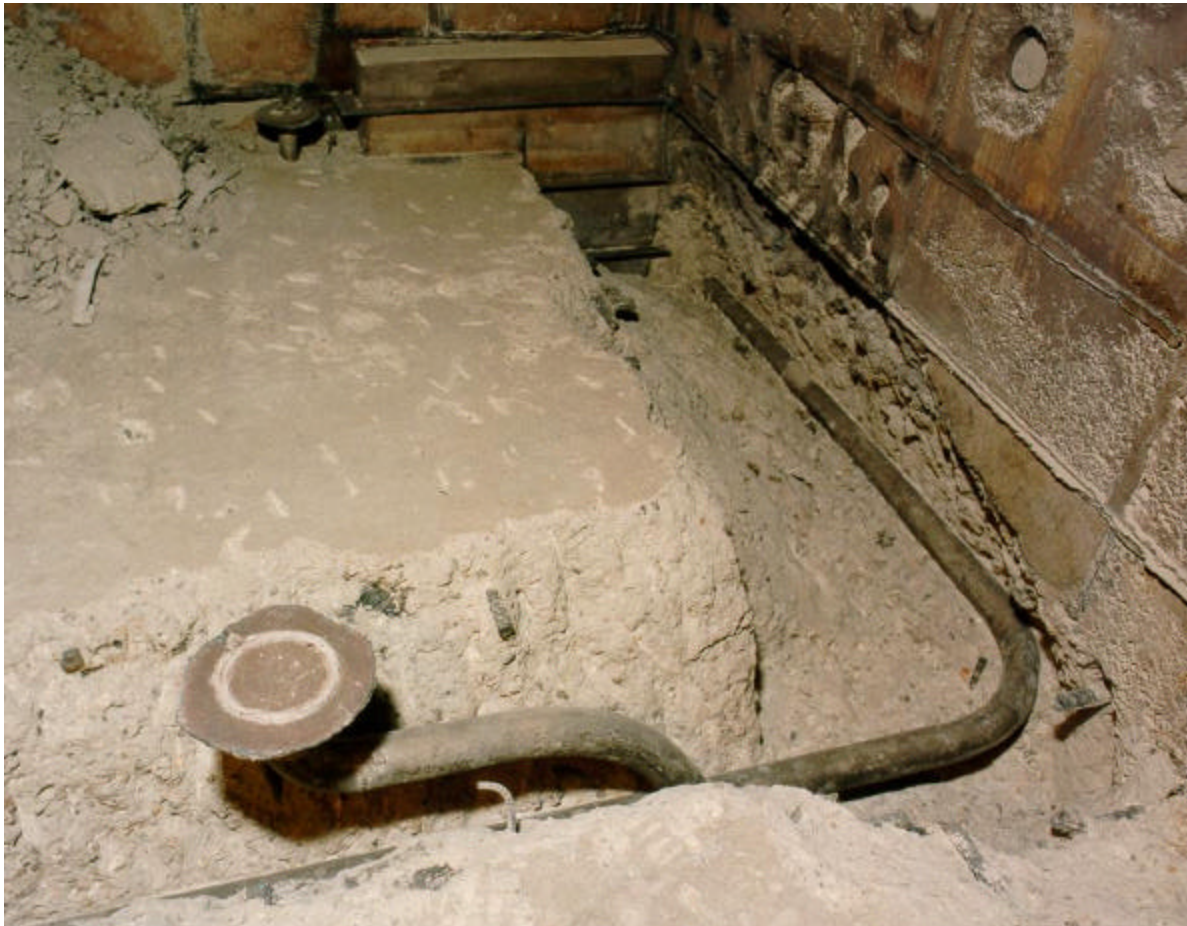
Figure 6-39. Radioactive Drain Line Removal in Cell 1. [AA31-03/22/93-S1003]

Access to the drains in the cells and decon rooms required the removal of substantial amounts of concrete from the floors, from the walls between cells (and beneath them), and from the basement ceiling. Examples are shown in Figures 6-39 and 6-40. Radiation levels were significant, with the highest readings adjacent to the drain lines. Those levels increased as the overlying concrete was removed above the Cell 2, 3, and 4 drain lines. Contact gamma radiation readings for removed drain lines included values up to 1 R/h for lines from Cell 2 and up to 5 R/h for lines from Cell 3. Their origin was debris inside the piping, principally metal shavings from 30 years of nuclear fuel declad and reactor disassembly operations. Localized shielding was used around exposed pipes for personnel protection, and debris was cleaned from the drain line sections as they were removed. Removal of the debris reduced drain pipe contact readings to 20-25 mR/h. Preliminary measurements of the debris suggested that it contained transuranic (TRU) material at levels in excess of 100 nCi/g, in addition to ^{60}Co . The debris was placed into vented one-gallon cans in shielded drums with HEPA filter vents and transferred to the RMHF for interim storage in a below-grade shielded vault.

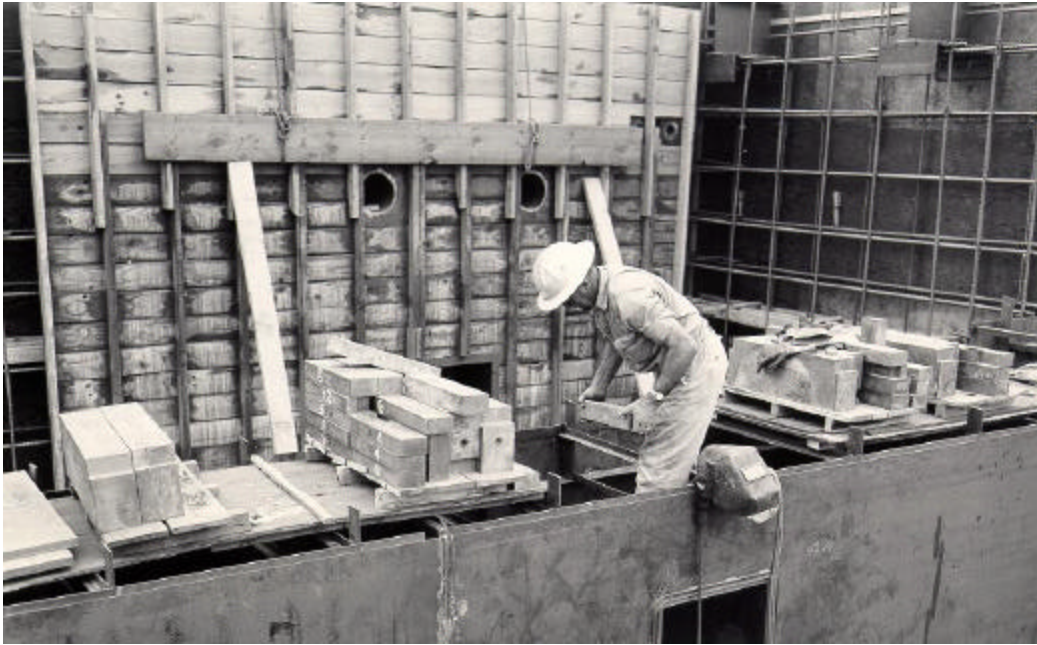
Figure 6-41. Construction Photograph Showing the Placement of Lead Shielding in the Cell 4 Steel Wall Frame Before the Concrete Was Poured. [00-57204, 10/6/58]

A large quantity of lead was incorporated in the facility structure during construction, including both blocks and poured-in-place shields. Its purpose was to prevent radiation streaming in critical areas. Figure 6-41, for example, is an old construction photograph that records the placement of lead blocks in a cell wall steel liner frame before the cell wall concrete was poured. Approximately 34,000 pounds of lead were removed from the cell and decon room areas during the D&D operations. Extra precautions were taken during the removal of the lead and the surrounding contaminated concrete to prevent radiological contamination of the lead. Nearly half of the lead removed required no decontamination prior to release for recycling. The balance was transferred to the RMHF for decontamination and recycle, or disposal where decontamination was not practical.

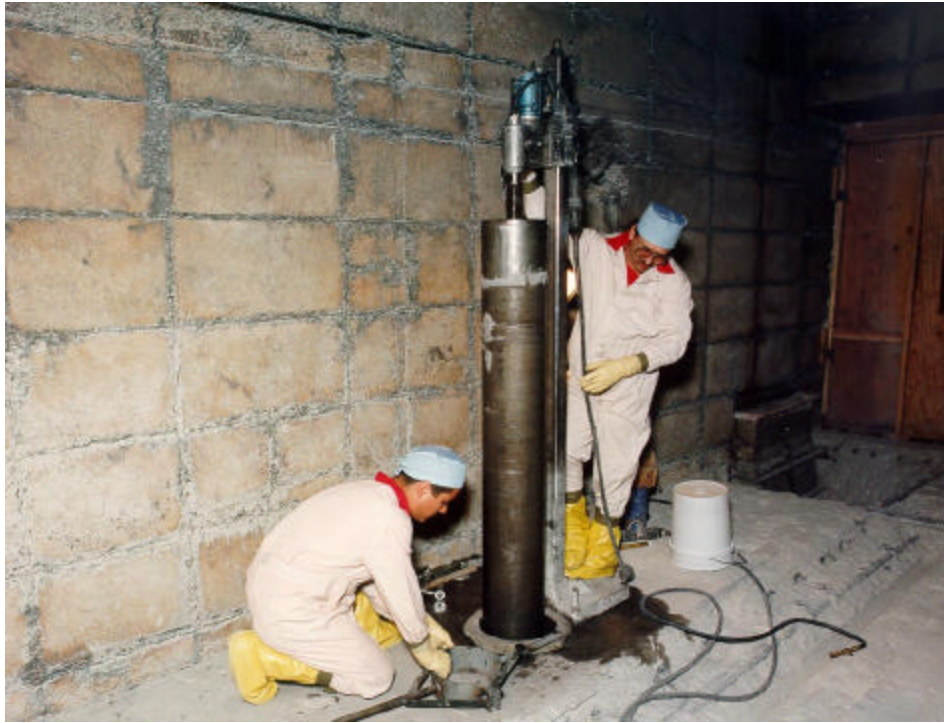
Figure 6-42. Core Drilling to Remove the Vertical Storage Tube in Cell 4. [AA33-10/18/93-S1001]

The removal of the penetrations in the hot cells and decon rooms was completed in FY 1994. Those penetrations had been left in place until this time because of elevated exposure levels. Subsequent facility D&D work significantly reduced those levels, and the concrete core drilling contractor used for previous operations was brought back in to complete the task. The core drilling technique was also used successfully to remove the 13-foot-deep vertical storage tubes located in the floor of each cell. Those tubes can be seen protruding from the tops of four of the concrete basement columns in the Figure 2-5 construction photograph (page 18). Figure 6-42 shows the core drilling operation, and Figure 6-43 is a photograph of the special storage tube lifting fixture that was fabricated to handle the large cores. The drilled cores were removed using a forklift, as shown in Figure 6-44, and size-reduced in the basement for packaging and disposal.

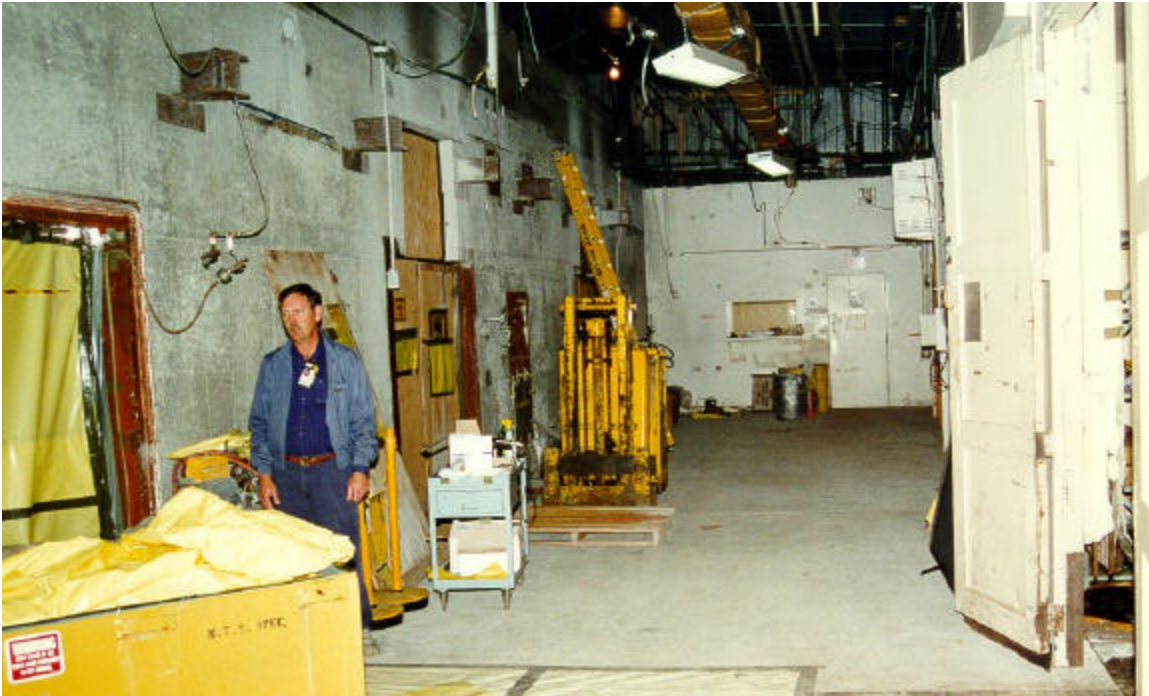
Figure 6-47. Status of the Service Gallery in March 1995, During Removal of Localized Contaminants from Adjacent Rooms. [SF31 03/20/95-S1001]

Removal of areas of localized contamination from the floor of the service gallery was completed in January 1995. The identification and removal of localized contaminants continued for the duration of the fiscal year in the hot cells and decon rooms. The significantly reduced radiation levels achieved by previous years’ activities allowed the optimization of D&D operations by using two crews in the controlled-entry hot cells and decon rooms. The crews worked in adjacent rooms and shared the same safety-watch (“cold”) support person stationed outside the immediate work areas. Figure 6-47 shows the status of the service gallery in March 1995, with a cold support person stationed outside one of the plastic-sealed work areas. The work plan called for the completion of the final room (Decon Room 2) in January 1996.
